March 11, 2022

Mr. Ronald Reily, Property Manager
Ultimar Three Condominium Association, Inc.
ultimar@rocketmail.com

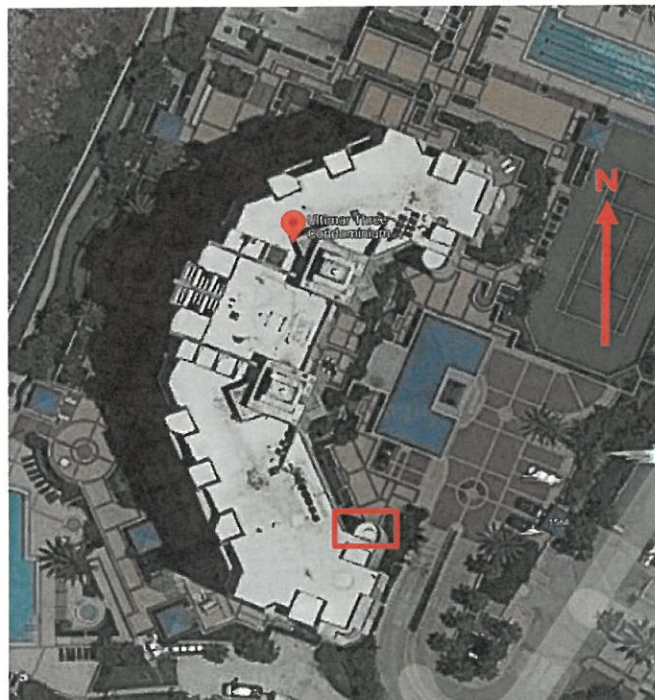
Site Photo of Property with the Approximate Area of Subject Column Identified

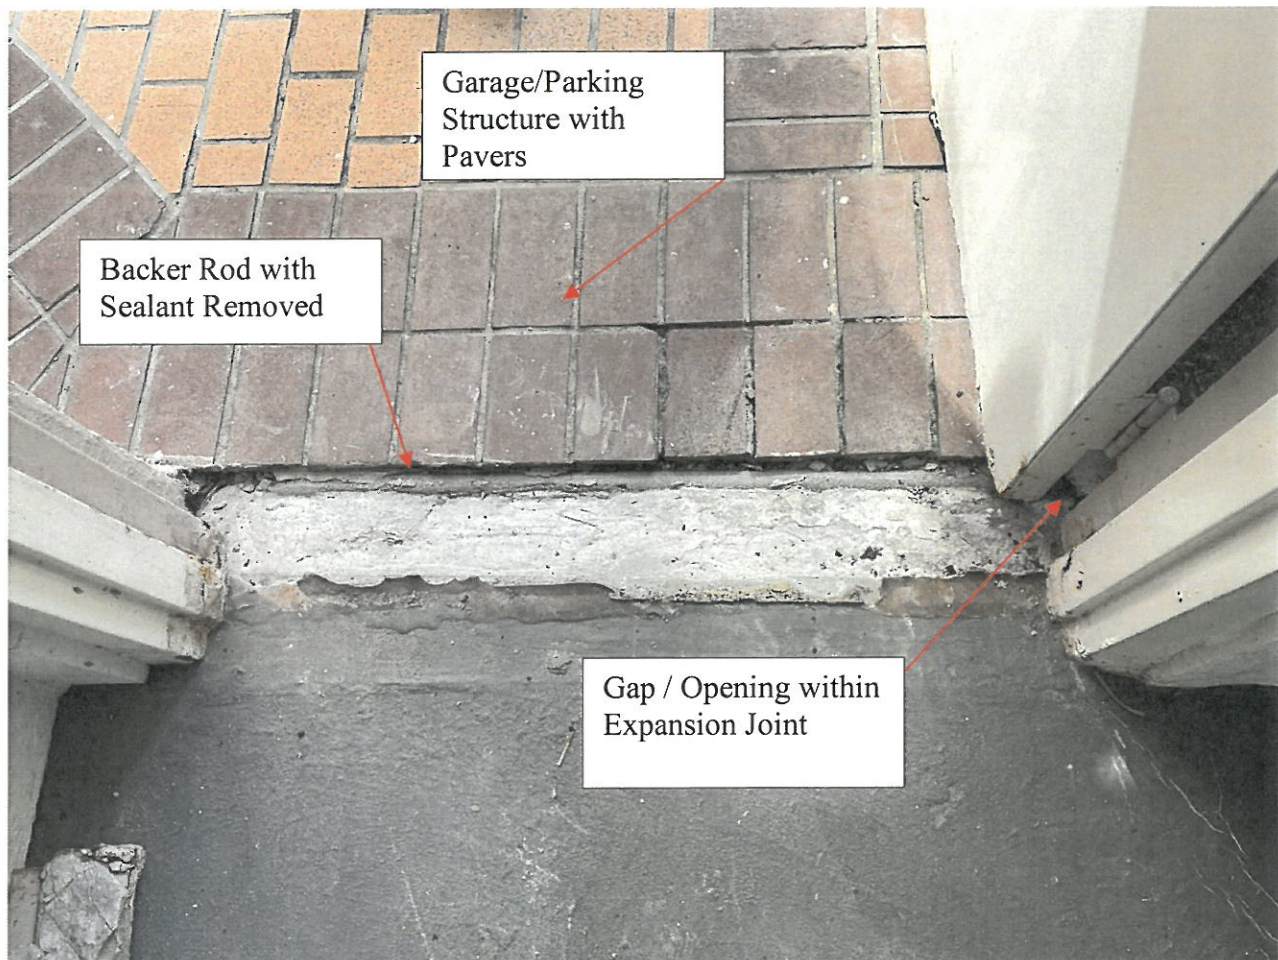
Figure 1: Stair Door Threshold Removed and Expansion Joint Sealant Removed (Corroded Door Frame)

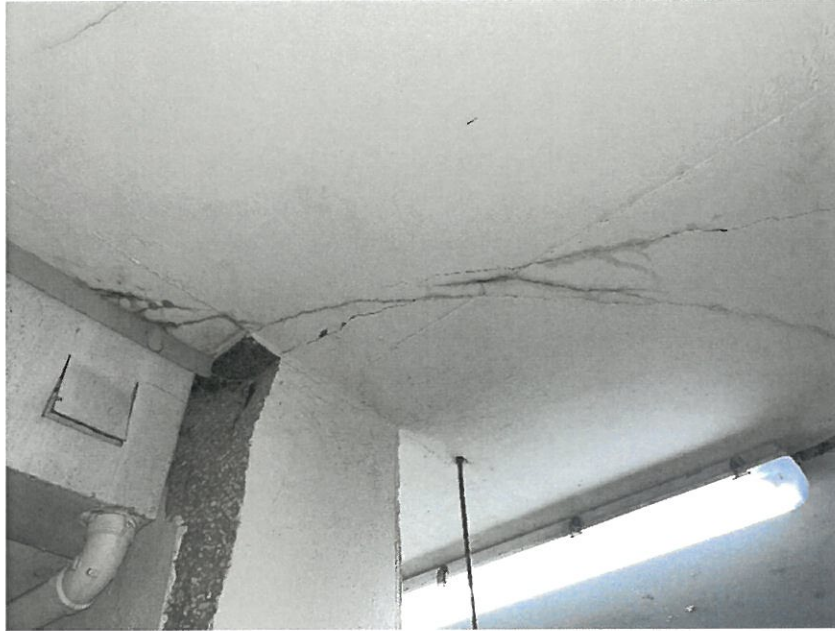
Figure 2: PAA-23 Concrete Column and Slab near Expansion Joint Observed to be Cracked/Spalled

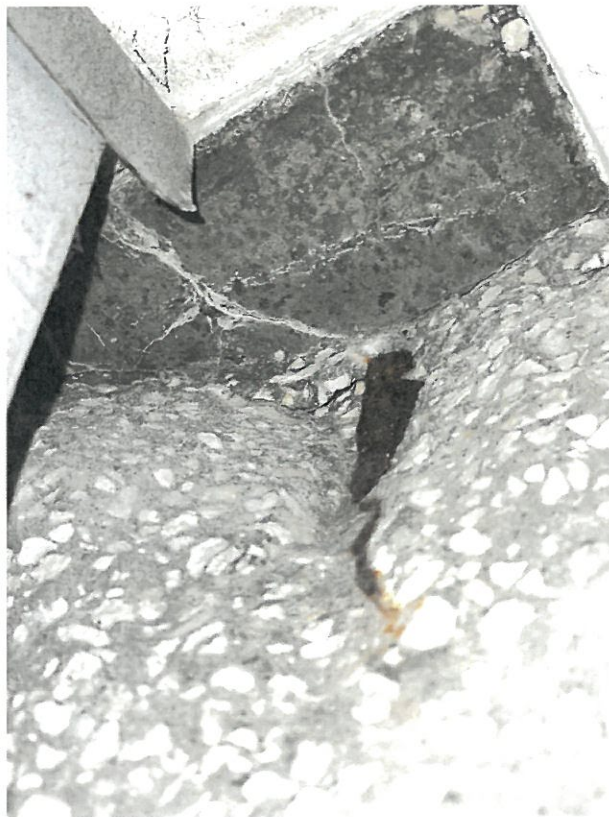
Figure 3: Close up of Exposed Column Reinforcement with Concrete Spall Removed

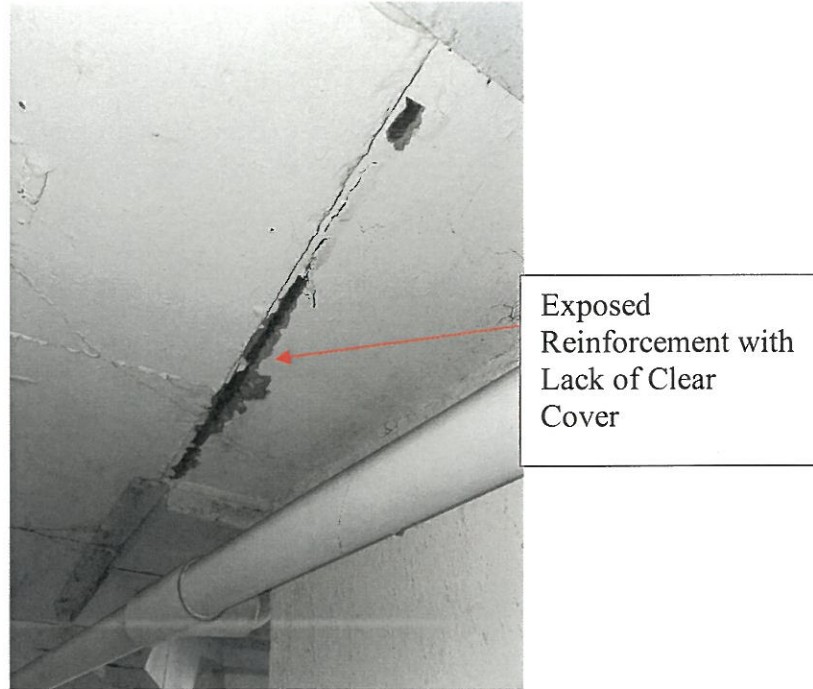
Figure 4: Exposed Reinforcement and Cracks on Garage Structure Side of Expansion Joint

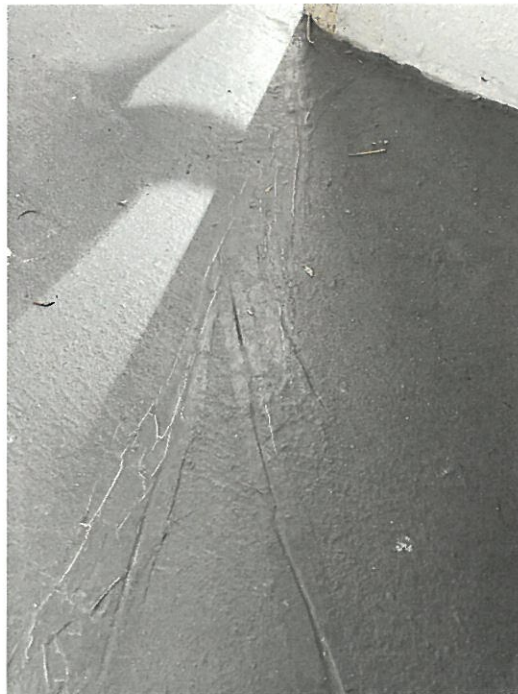
Figure 5: Previously Repaired Cracks within Stairwell
